USAAVLABS TECHNICAL REPORT 69-42

**FLAW POINT AND DYNAMIC
MICROPHOTOELASTICITY INVESTIGATION**

**U. S. ARMY AVIATION MATERIEL LABORATORIES
FORT EUSTIS, VIRGINIA**

CONTRACT DAAJ02-68-C-0023

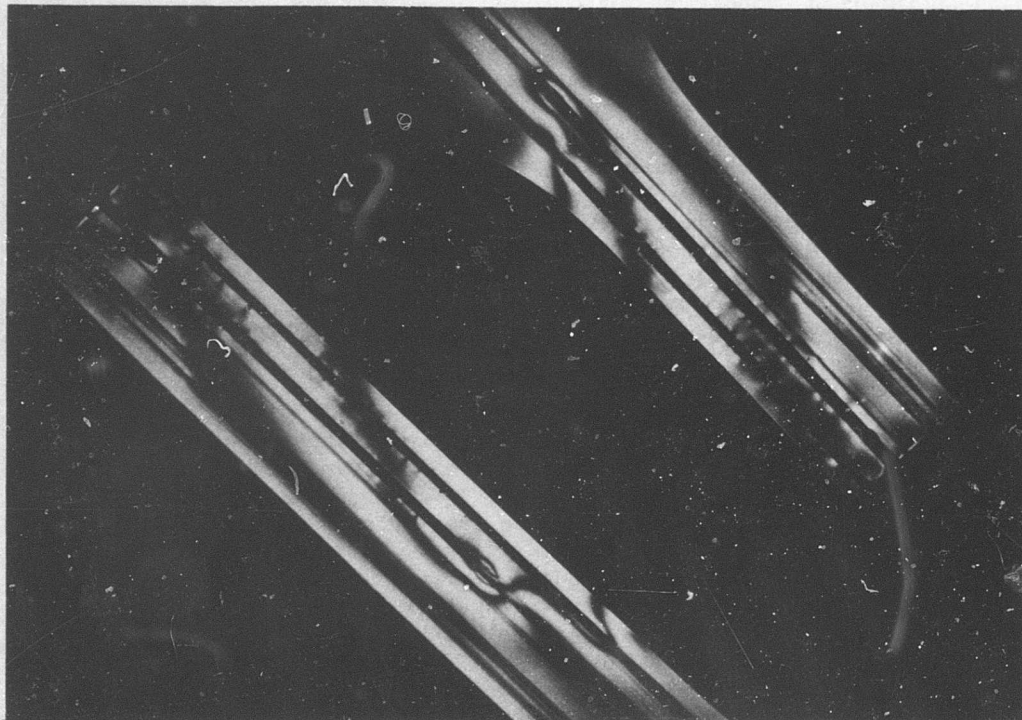
Six 0° fiberglass-reinforced specimens were subjected to axial tension. Fracture occurred very rapidly, and the action was not stopped by a Milliken camera operating at 400 frames per second. The average ultimate stress for five specimens (one specimen failing in the grips) was 18,700 psi. In each case a brittle-type failure occurred. A few small secondary cracks developed at the fibers near the main crack. Fracture was accompanied by unbonding of fiber bundles away from the fracture surface. Distinct residual stress patterns associated with the unbonded fibers were observed. A typical residual stress pattern is shown in Figure 2.

Figure 2. Residual Stresses in Unidirectional Fiberglass-Reinforced Tensile Specimen Showing Unbonding of Fiber Bundles (1.8X) .

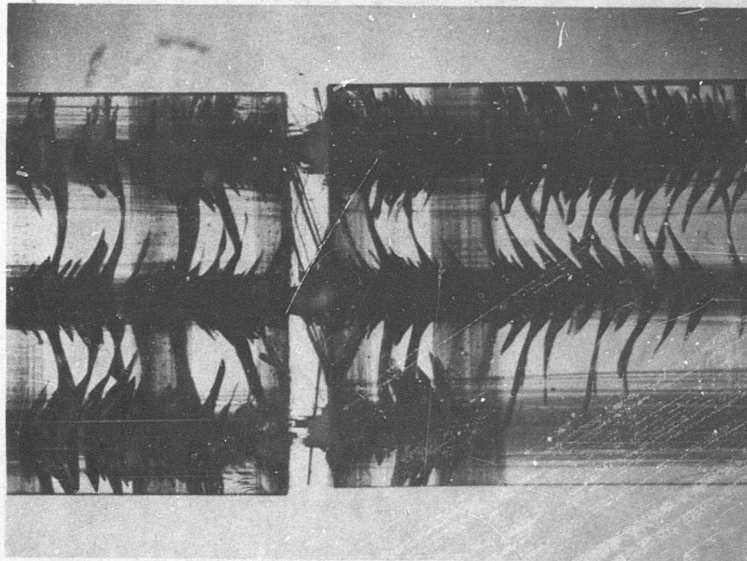
Dish-shaped crack formations were present, to a greater or lesser extent, in all of the 0° - 90° cross-ply specimens tested. Two cases of extensive stacked crack formations are presented in the posttest photographs of Figure 4. Several pertinent observations can be made from these photographs. Here, as in all other stacked crack formations, the dish-shaped cracks are concave toward the main fracture. Also, transverse fibers tend to inhibit the formation of these cracks.

Figure 4. Posttest Details of Stacked Crack Formations in a 0° - 90° Fiberglass-Reinforced Specimen (5.1X).

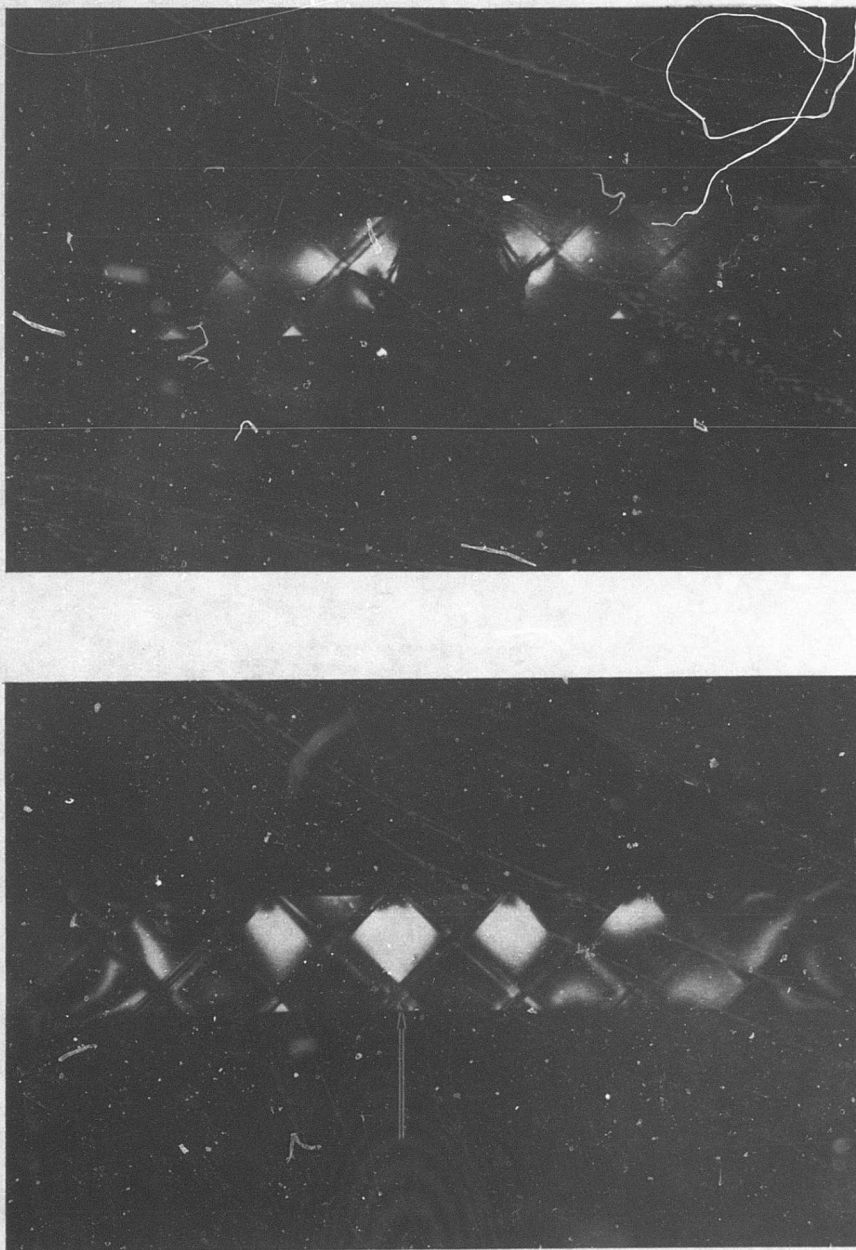
Tensile specimens having glass fiber orientation of $\pm 45^{\circ}$ demonstrated some basically different failure characteristics. Failure always initiated at locations where fiber bundle crossover points were at or near the edge of the specimen (arrow in Figure 5). The basic mechanism of failure was shear along the fibers. This was accompanied by local stacked cracks at the crossover point and some unbonding along the fiber bundles intersecting at the crossover point.

Figure 5. Failure of $\pm 45^\circ$ Cross-Ply, Fiberglass-Reinforced Tensile Specimen Initiated at Fiber Bundle Crossover (1.4X).

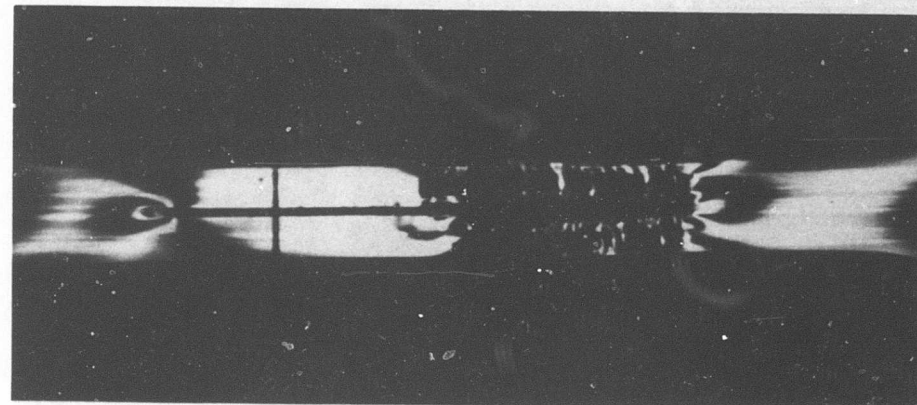
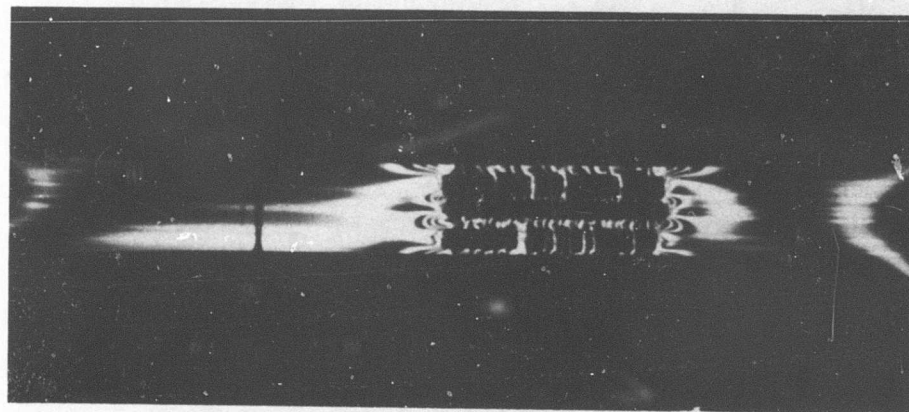
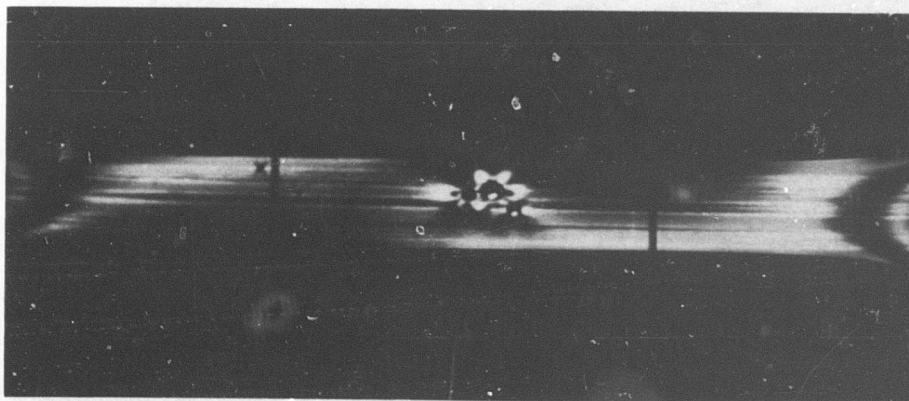
An example of the effects of a cluster of macroscopic bubbles in the vicinity of fiber bundles is presented in Figure 10. A remarkable alteration of the behavioral pattern of 0^0 fiberglass-reinforced specimens can be observed here. Whereas all previously tested 0^0 specimens exhibited no stacked crack formations, the specimen presented in Figure 10 developed a very intricate array of stacked cracks. Unbonding of the central fiber bundle occurred after formation of the stacked crack array. An average ultimate stress for three specimens with large voids was 13,360 psi, compared with 18,700 psi for five unfaulted specimens.

Figure 10. Influence of Large Bubbles on Failure of Fiberglass-Reinforced Tensile Specimen (1.1X).

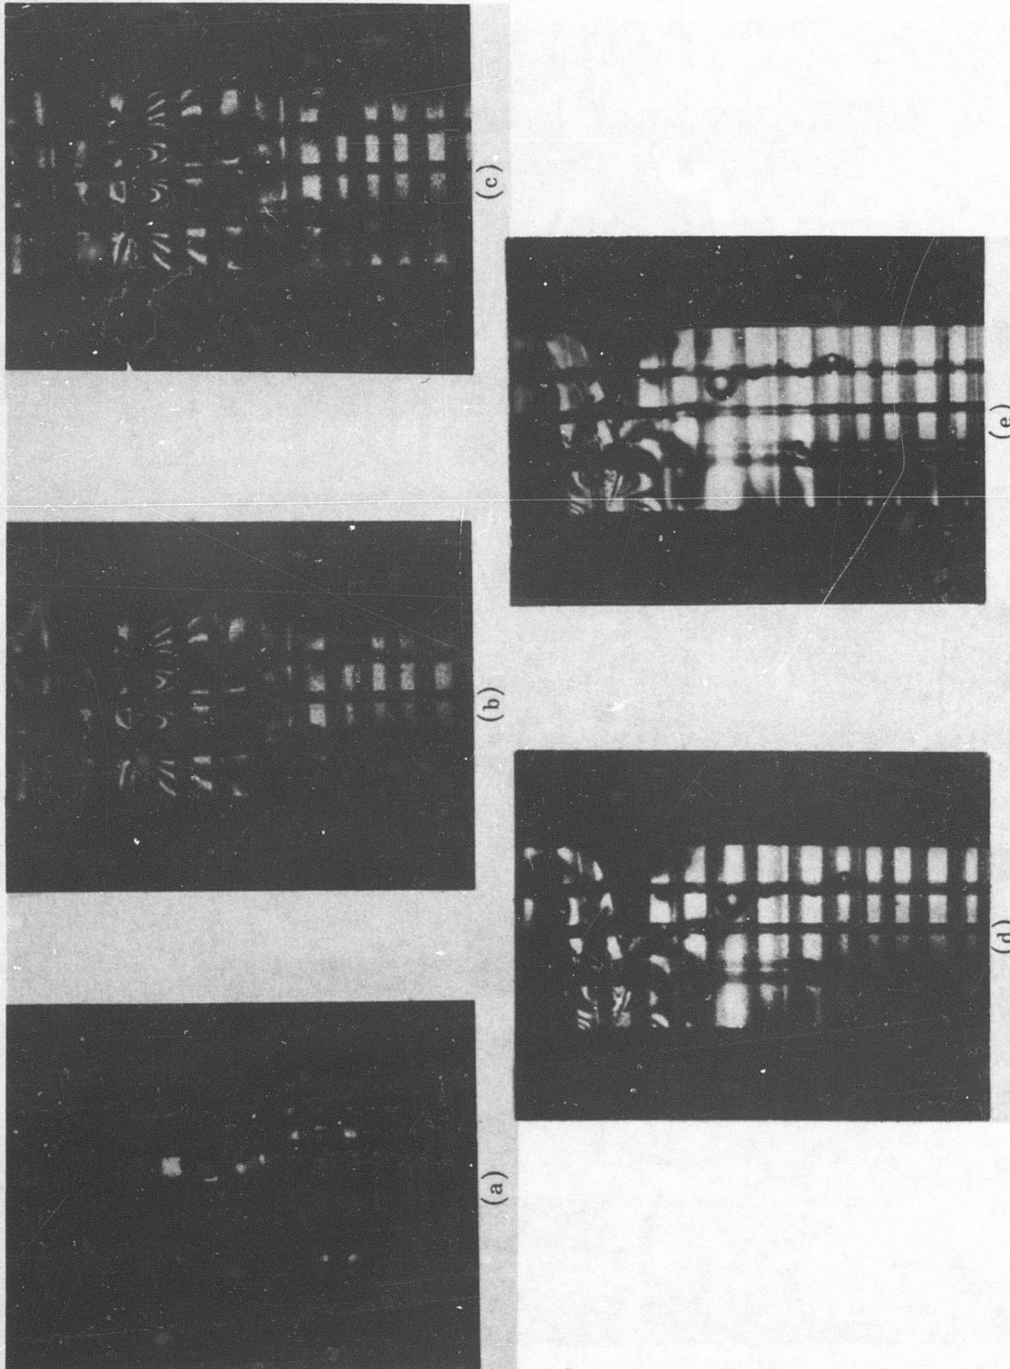
Initial flaws did not appear to alter the behavior of the 0^0 - 90^0 glass-reinforced specimens. An example of this is presented in Figures 11 and 12. This specimen contained clusters of bubbles, some of which were quite large. Failure initiated at the edge of the specimen at a transverse fiber bundle. Little difference could be seen between the ultimate stresses in 0^0 - 90^0 specimens with flaws (voids, cut and contaminated fibers) and those without flaws. In every case, failure initiated at transverse fiber bundles.

Figure 11. Cross-Ply Fiberglass Uniaxial Tensile Test
(2.2X).

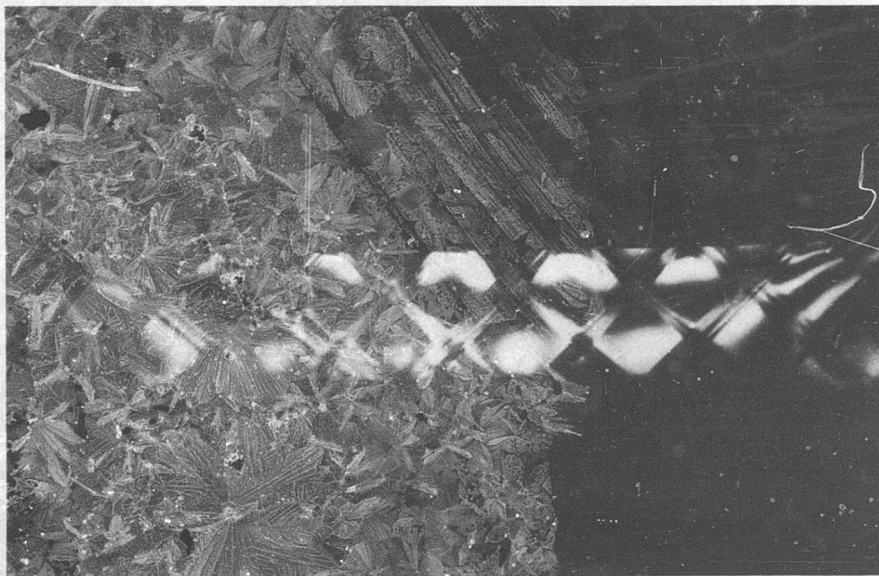
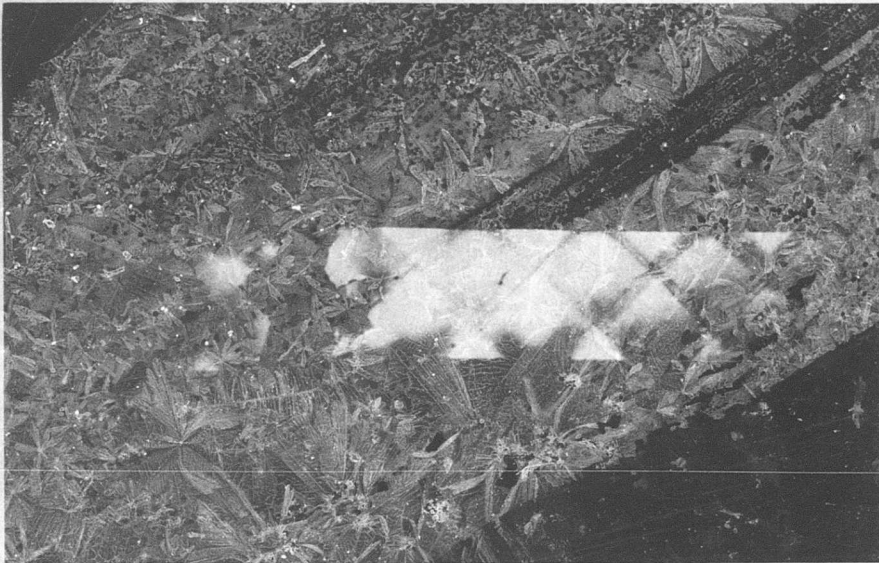
Two specimens reinforced with glass fibers at $\pm 45^0$ and containing bubbles were tested. Both these $\pm 45^0$ specimens exhibited extreme sensitivity to the presence of voids. Figures 13 and 14 illustrate this significant aspect of composite behavior. Failure was a shear type and was accompanied by local stacked cracks at crossover points and some unbonding away from the crossover points.

Figure 13. Failure Initiated by Bubbles in $\pm 45^\circ$ Cross-Ply, Fiberglass-Reinforced Tensile Specimen (1.6X).

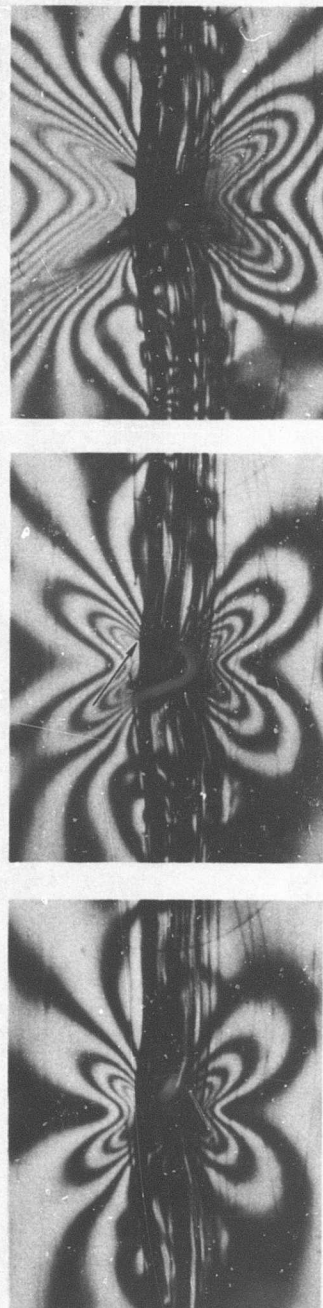
A very interesting crack growth formation was observed in the vicinity of a void in a 0° Morganite-reinforced specimen. Figure 16a shows a stress pattern around the void similar to the classical pattern found around a hole in a plate subjected to tension. The arrow in Figure 16b points to the tip of an advancing crack. Figure 16c shows the fully developed crack curving away from the void. Final specimen failure occurred at the grips. A posttest high-magnification photograph of the void region is presented in Figure 17. Examination under the microscope revealed that there was no fiber fracture in the vicinity of the void or cracks.

Figure 16. Crack Formations Near Void in Morganite-Reinforced Tensile Specimen (6.6X).

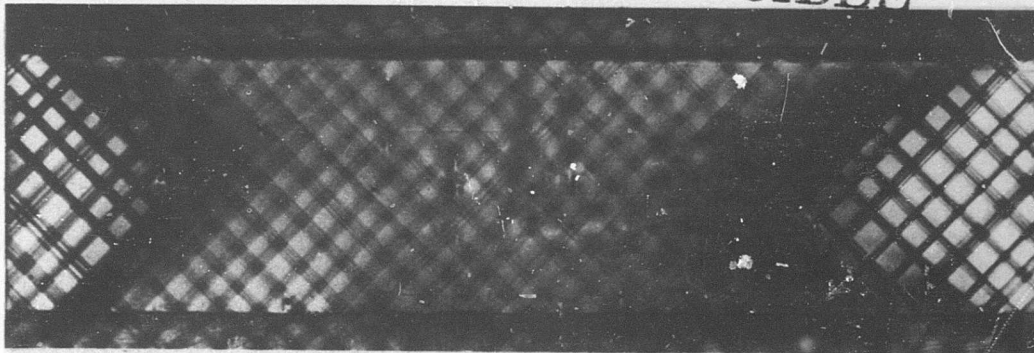
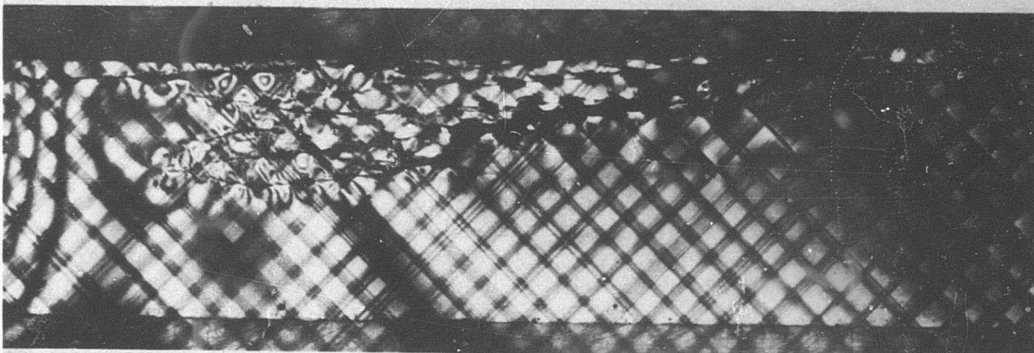
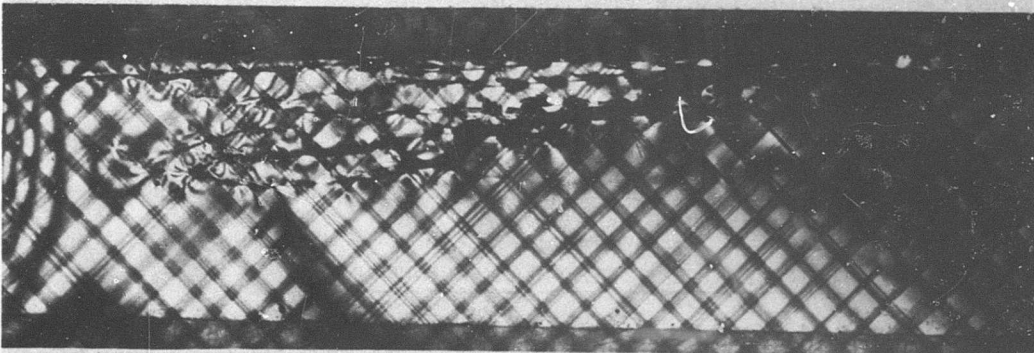
Figure 24. Failure of $\pm 45^\circ$ Glass-Reinforced Biaxial Strip Specimen (1.6X).

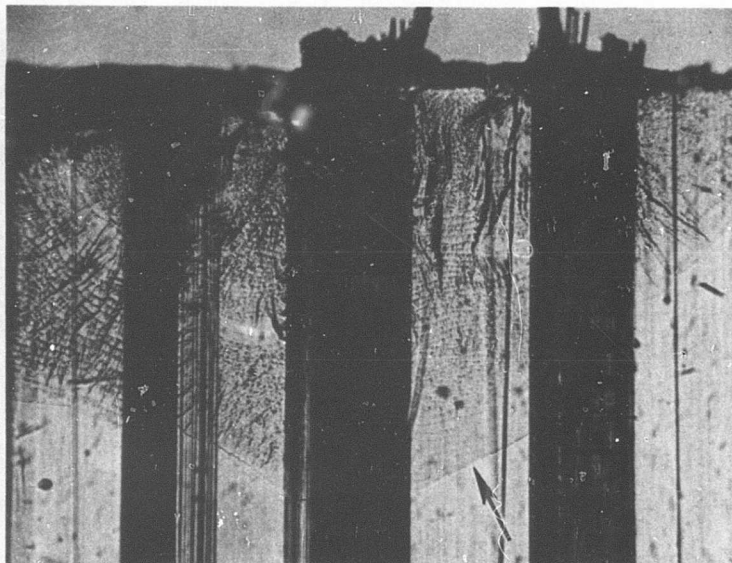
A detail of the fracture of a fatigued unidirectional glass-reinforced specimen is shown in Figure 28. This failure is entirely different from any observed in static testing. No stacked cracks are present, but there are arrays of fish-scale-like cracks emanating radially from broken fiber ends; and there are cracks parallel to, and between, fiber bundles. A definite boundary (arrow) is present between the region containing the fish-scale-like cracks and the uncracked region. Observation with polarized light revealed different refractive indices on each side of this boundary. This effect is often caused by excessive local heating and may be evidence that considerable heat was present at the time of fracture. There are also cracks close to the fibers, and running normal to the fibers, which do not extend into the region between bundles. These latter cracks are not easily discernible in Figure 28. Failure of this specimen occurred after 737 cycles. No load decay was evident before failure.

Figure 28. Detail of Fatigue Failure (after 737 cycles) of Unidirectional Glass-Reinforced Composite (50X).

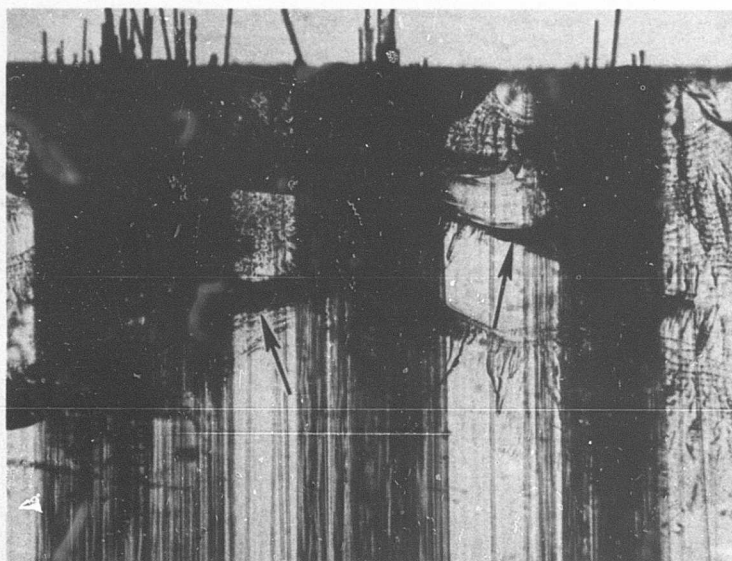
Figure 29 shows another unidirectional glass composite which failed after undergoing only 234 cycles. Although there was some evidence of heating, the effect was not nearly so pronounced as that shown in Figure 28. Larger cracks across the fiber bundles (arrows) extend into the matrix between the bundles. There was no load decay before failure. The difference between the two failure modes could be explained by a difference in temperature rise in the two specimens.

Figure 29. Detail of Fatigue Failure (after 234 cycles) of Unidirectional Glass-Reinforced Composite (50X).

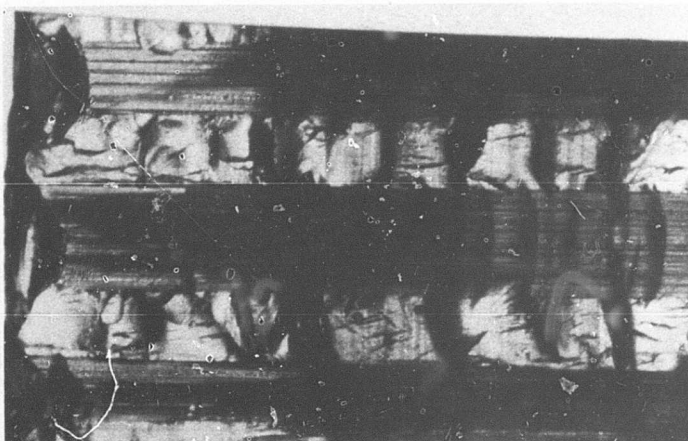
Figure 32. Detail of Fatigue Failure of Cross-Ply Glass-Reinforced Composite (23X).

Figure 32 is a detail of piece A with piece B removed. The interlaminar fracture surface can be seen in this photograph.
